# Multiple Fatality Single-Family Dwelling Fire

St. Cloud, Florida

USFA-TR-142/June 2001

Investigated by: John Lee Cook, Jr.

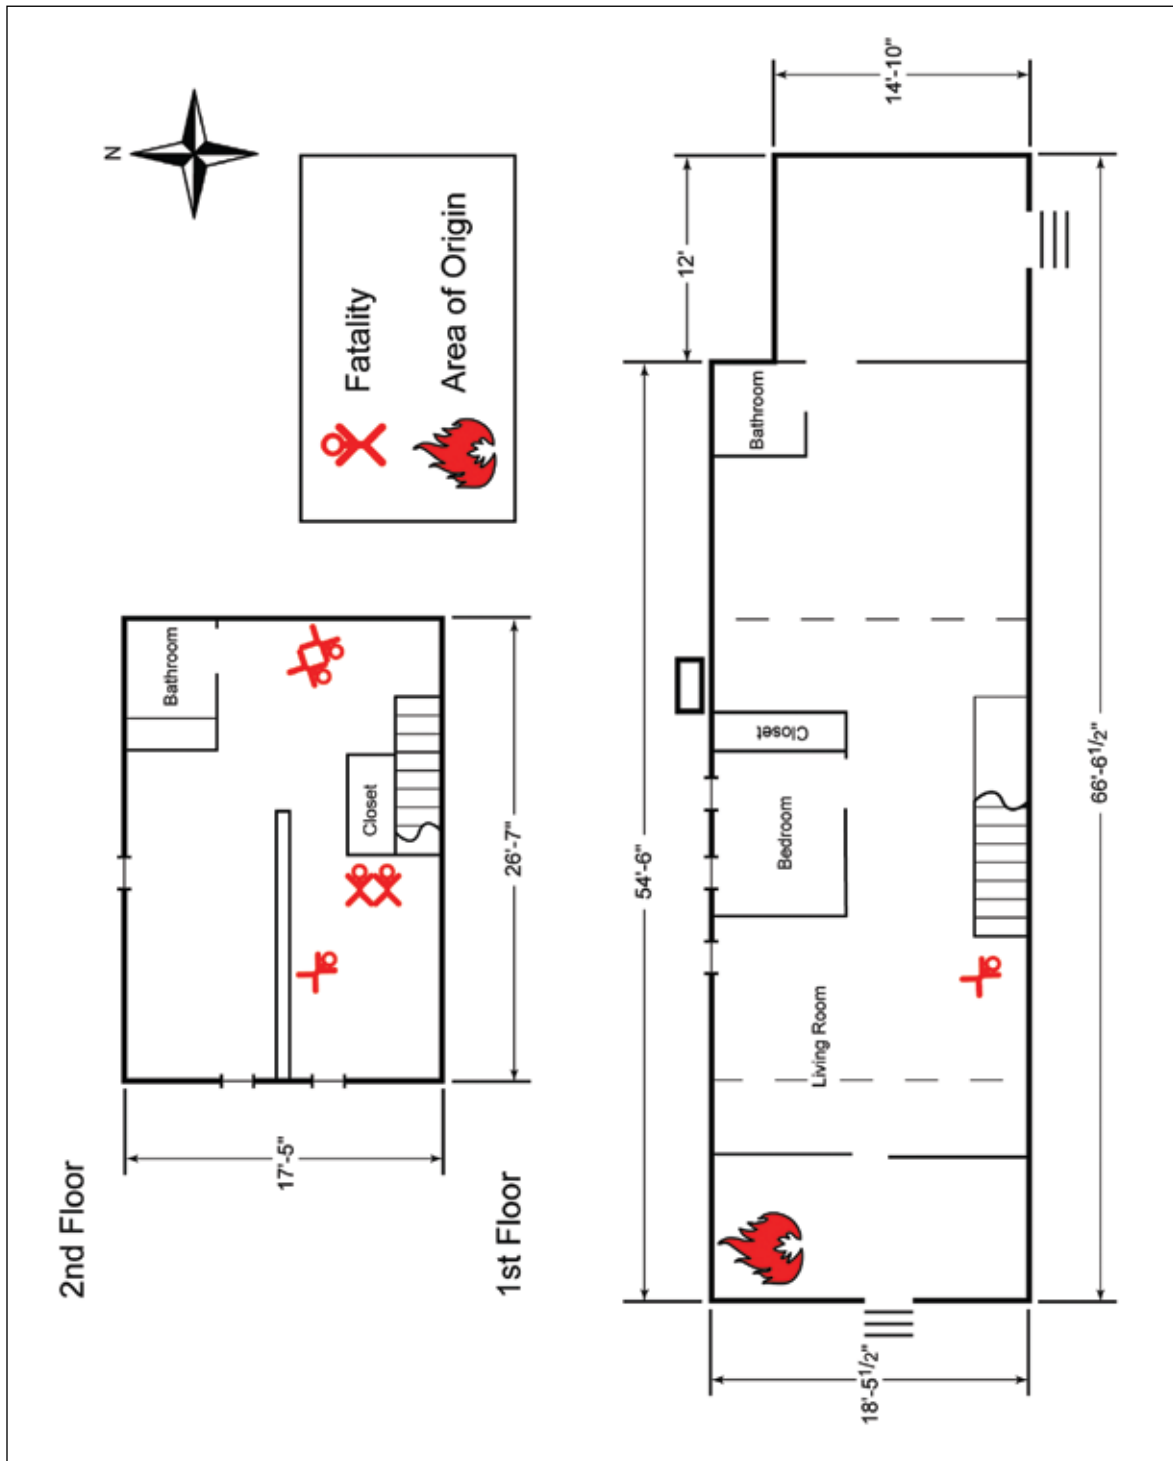
Diagram One: Sketch of the Floor Plan

The firefighters knocked down the fire on the second floor and discovered what they initially thought was two victims. Upon entering the second bedroom, firefighters found two more bodies by the rear window (see diagram 1 for the location of the victims, page 12). At this point, the IC requested that the department's Chaplain, the Medical Examiner from Orange County; the State Fire Marshal; and the local fire marshal be dispatched to the incident.

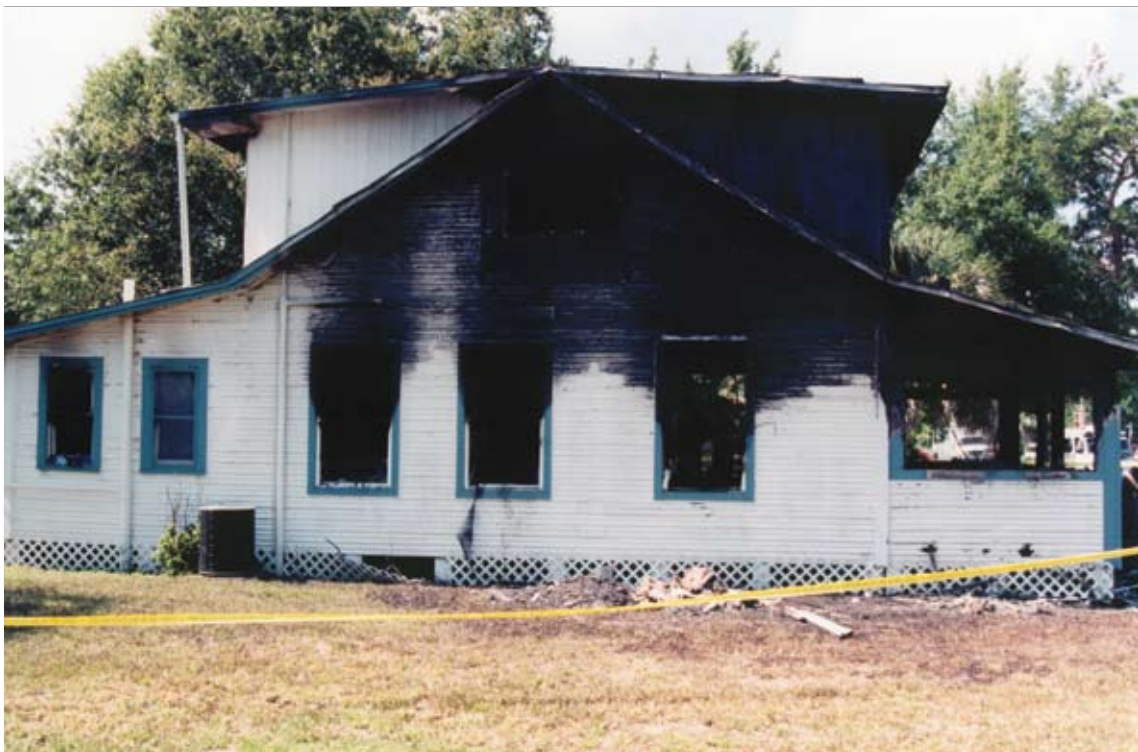
**#4** View of north side of house; note multiple roof lines indicating possible enlargement of second floor

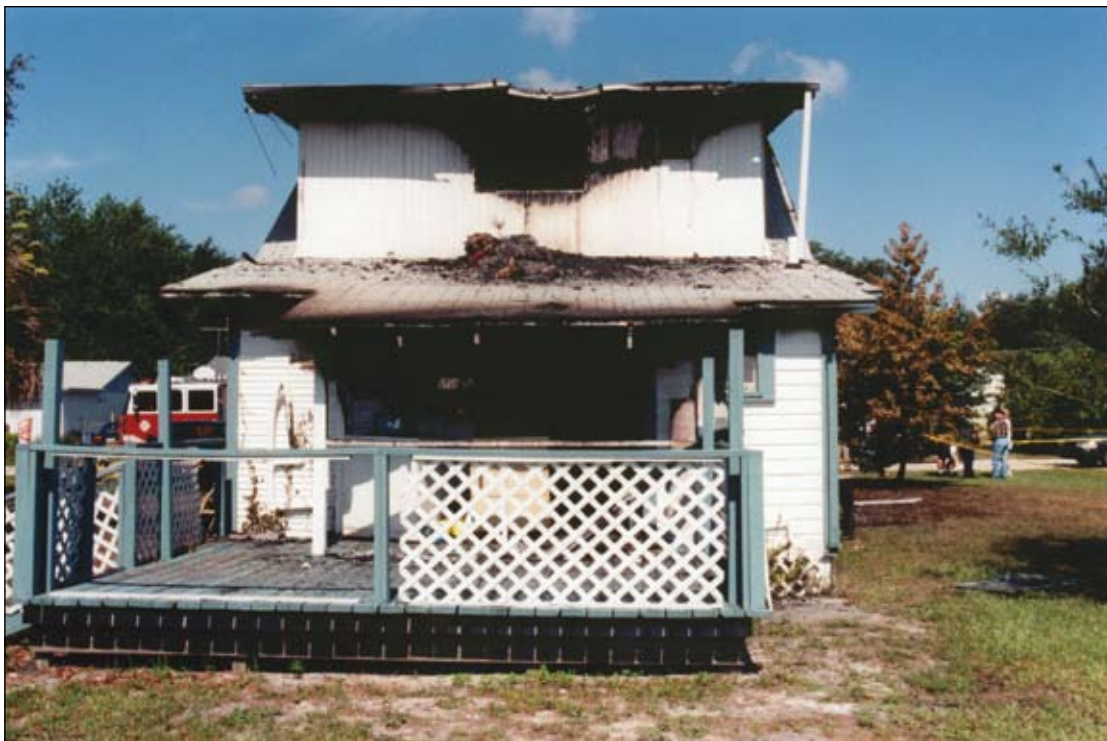
#6	Day time view of rear of house and open back porch; note: this is where male occupant climbed up and broke out rear window and called for children; two bodies located just inside the rear window on second floor

**#6** Day time view of rear of house and open back porch; note: this is where male occupant climbed up and broke out rear window and called for children; two bodies located just inside the rear window on second floor

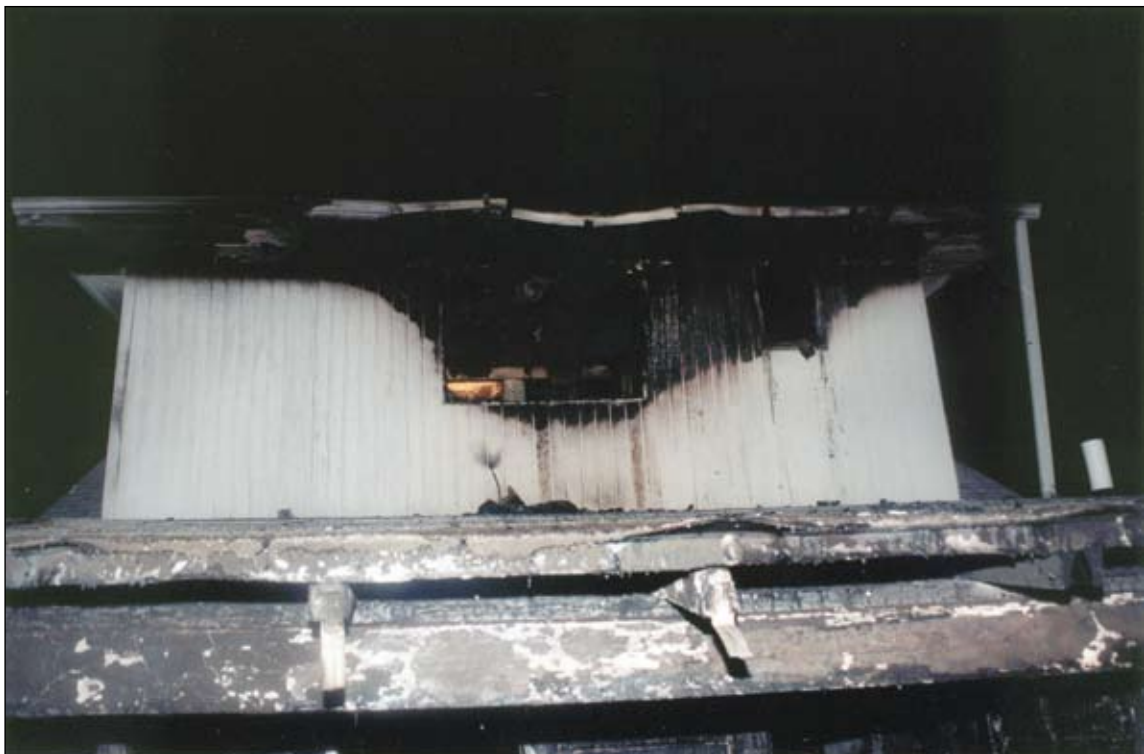
**#8** Exterior view of second floor window of rear bedroom; note charring pattern

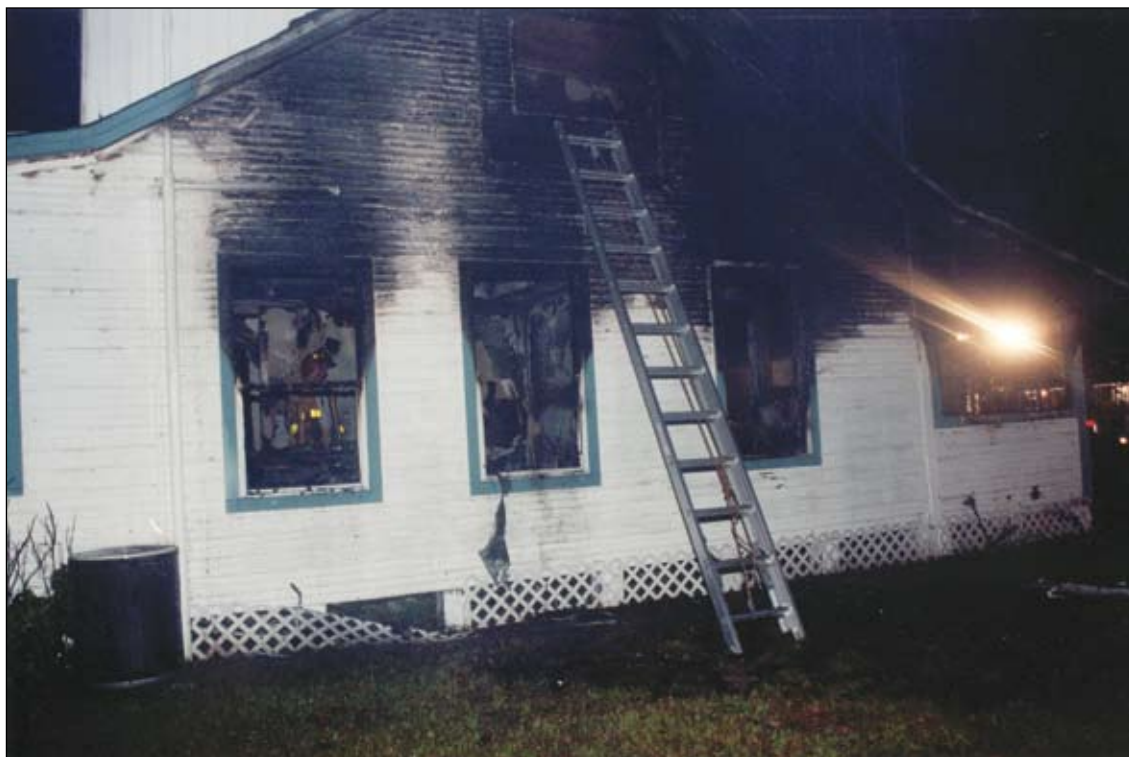
**#10 Another view of north wall of house; note ladder and char patterns above all three windows**

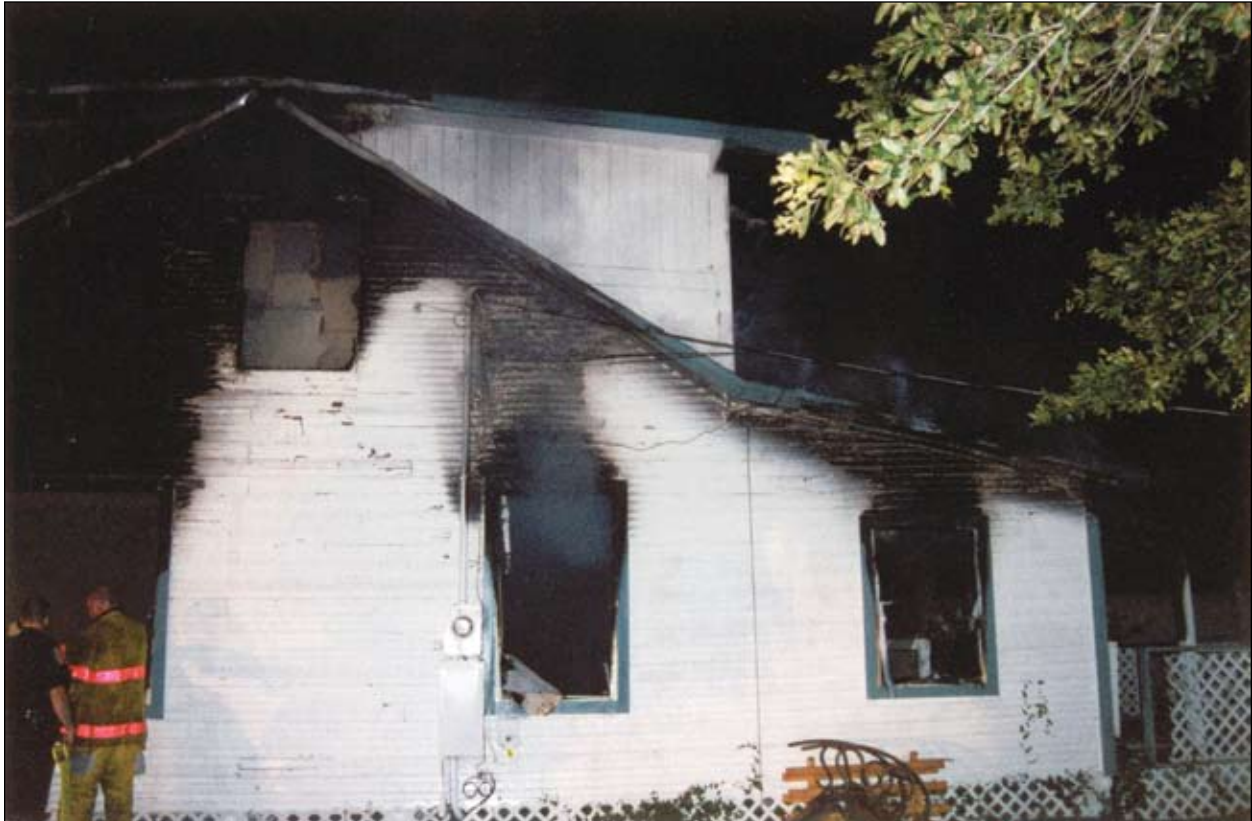
**#11 Night view of southern wall; again pattern of exterior side indicative of former enlargement of second floor**

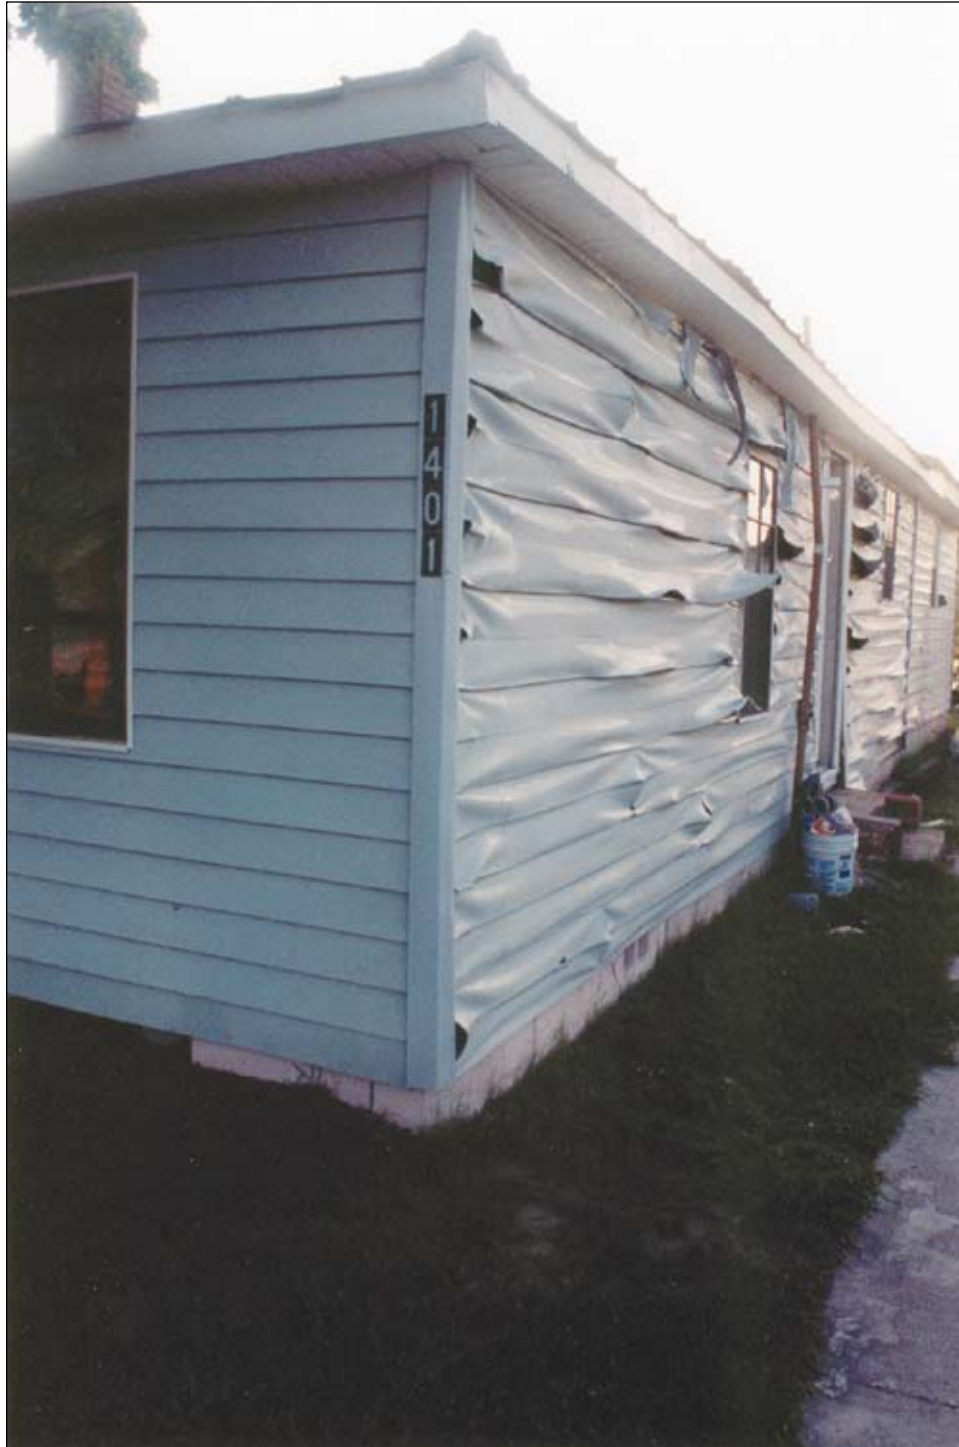
While Engine 101's crew was pulling an attack line, the officer began to make a 360-degree size-up, but encountered a downed power line on the south side of the structure. Unable to complete his walk around, the officer ordered that the 1-3/4-inch attack line be used to protect the exposure on the north side of the fire because the siding on the exposed single-family dwelling was beginning to melt.

#12 Northern exposure; note melting of exterior vinyl siding

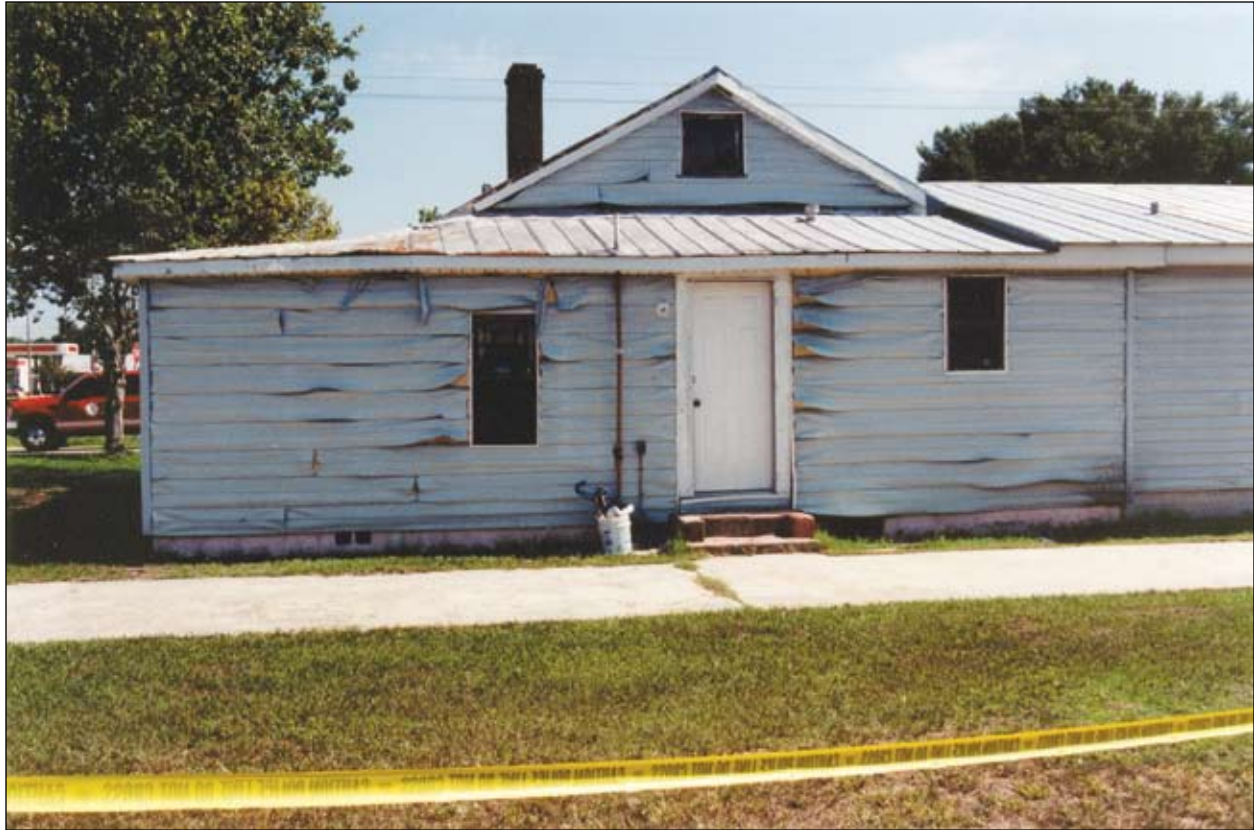
**#13 Northern exposure; note melting of exterior vinyl siding**

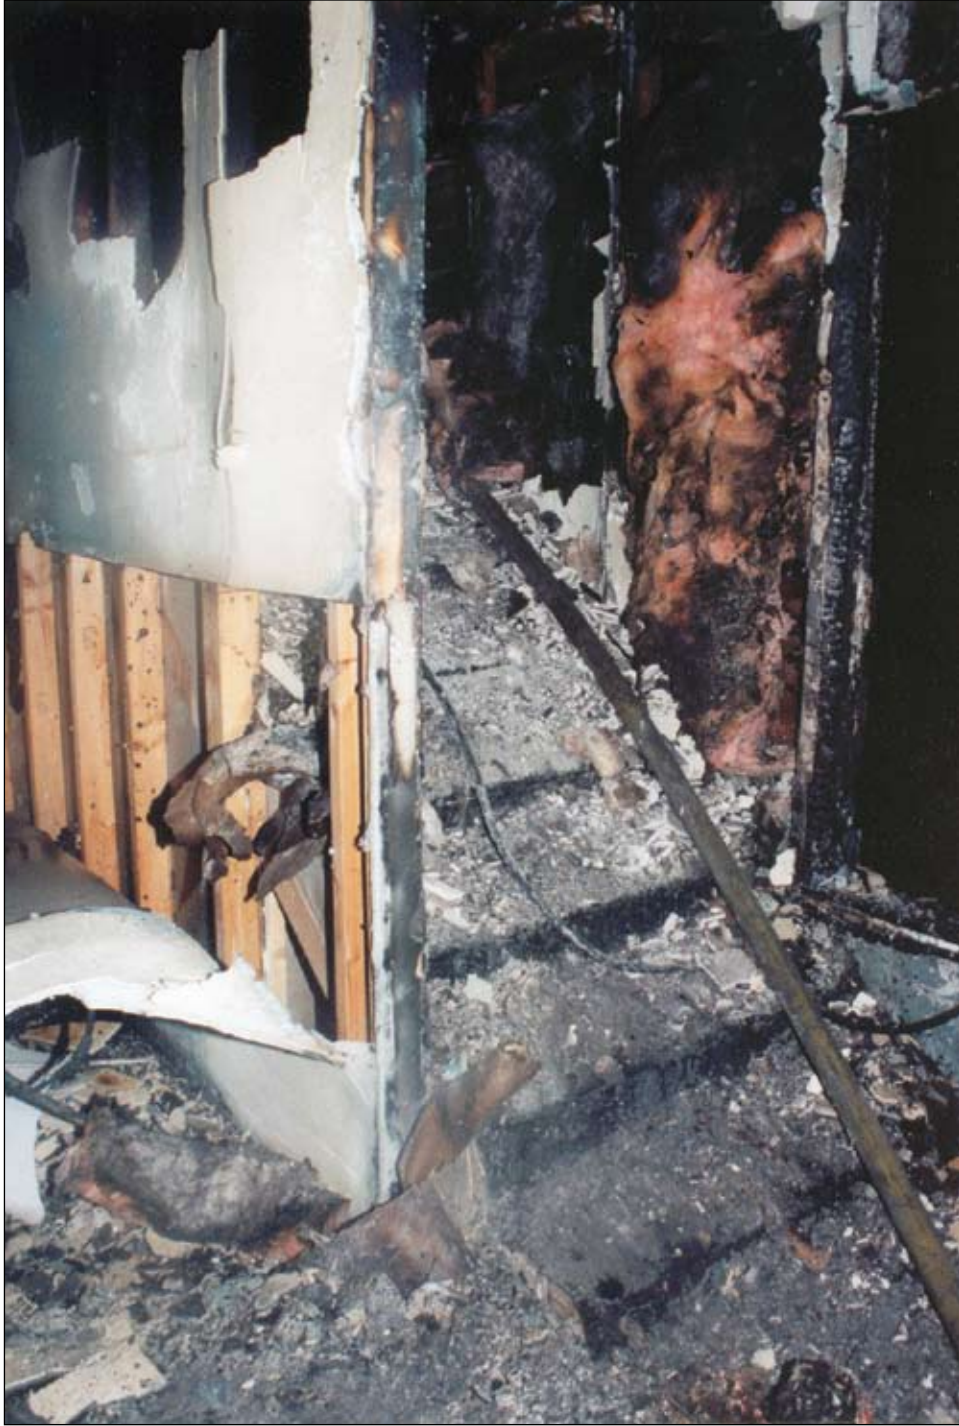
**#14** Hose line extending up interior stairwell; note accumulation of debris

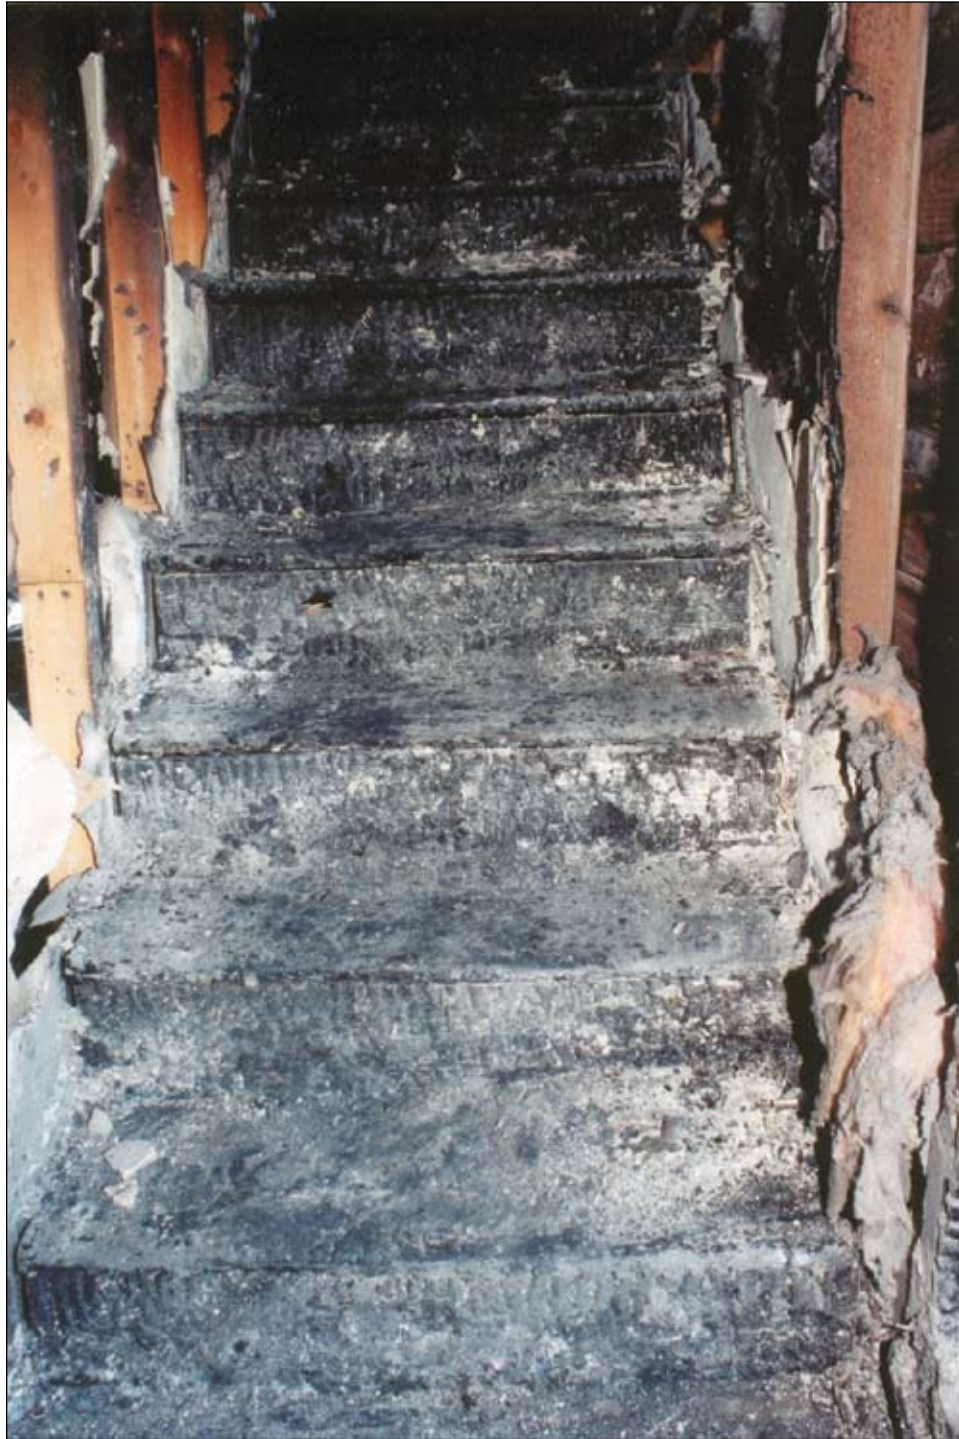
**#15 View up the stairs from first floor; note deep charring on stairs**

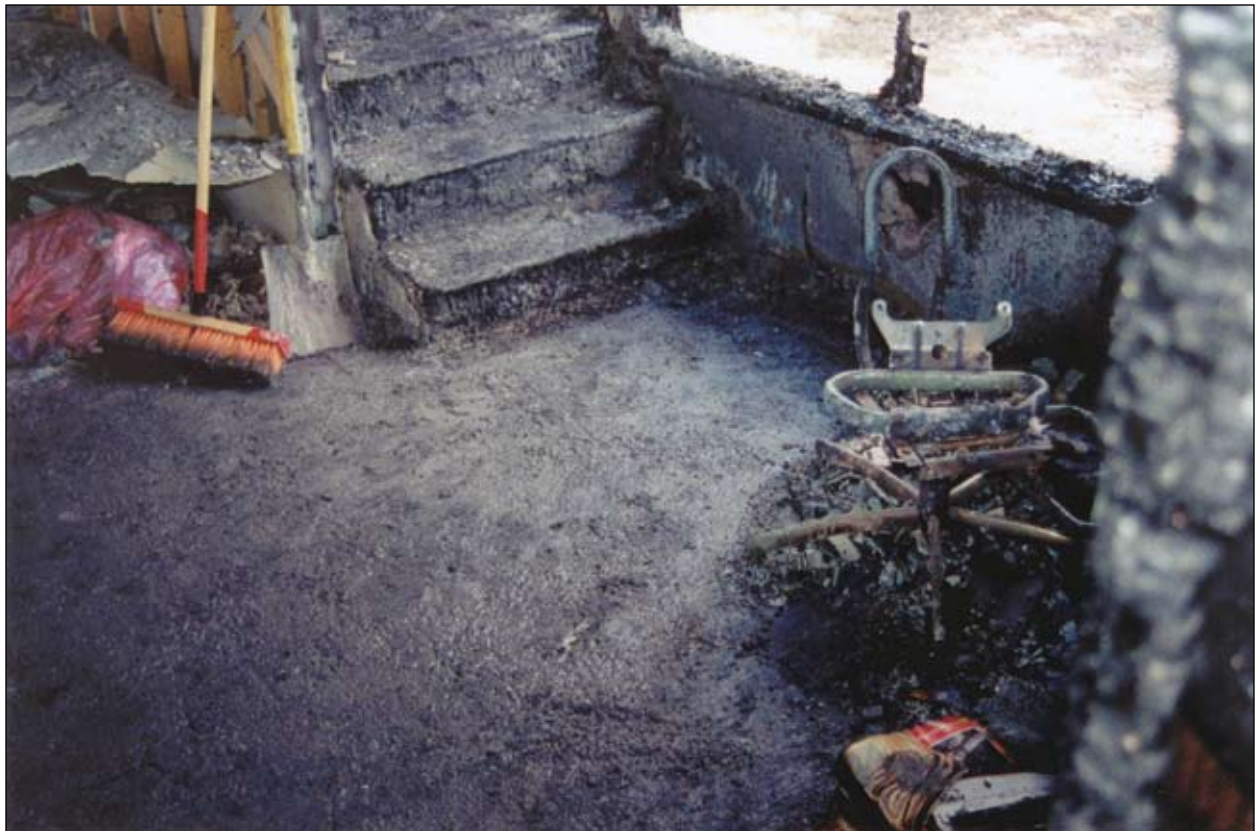
Firefighters began to exhaust the contents of their first bottle of air and backed down the stairs at which point they were advised by the officer of the Engine 201 that there was an additional victim at the base of the stairwell, bringing the total victims to five. The body had been difficult to recognize due to severity of burns.

**#19 Day time view of base of stairs, which has been cleaned to the floor. Fifth victim was discovered at this location by Engine 201**

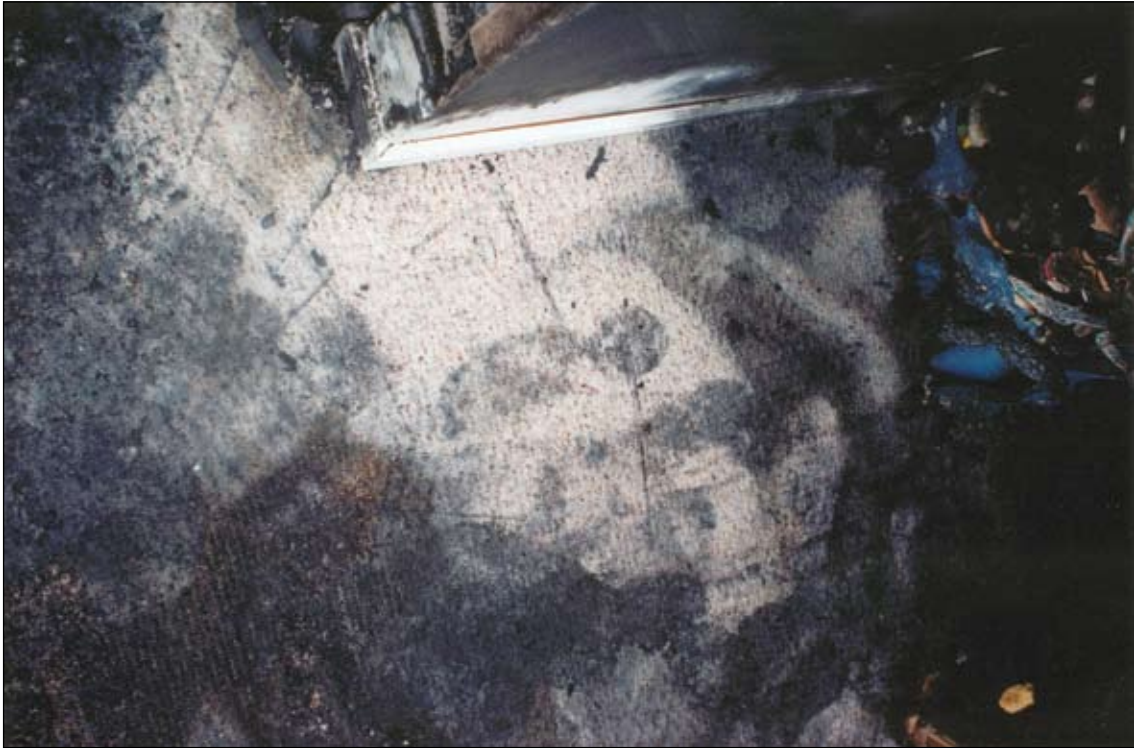
**#21** Location of victims one and two (ultimately six) just inside landing of stairs on second floor, note lack of burns and smoke pattern on carpet

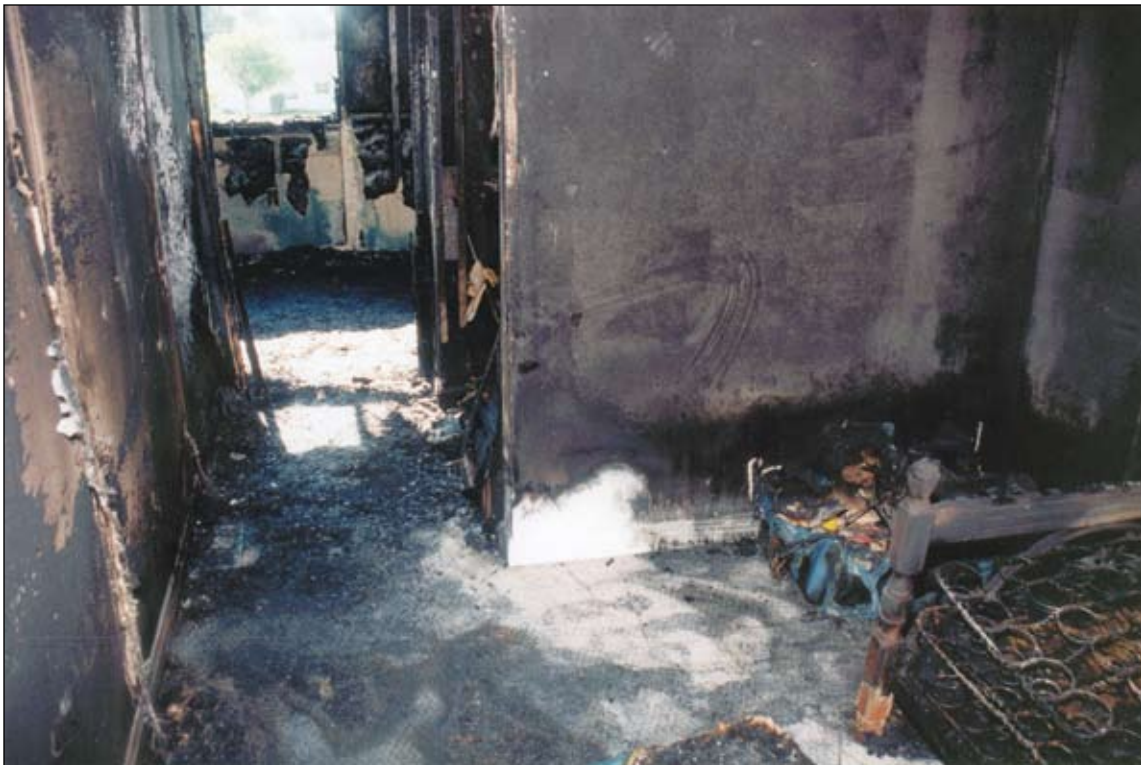
**#22** Additional view of victims one, two, and six; note lack of burn/smoke on baseboard due to adult female's head coming to rest against wall

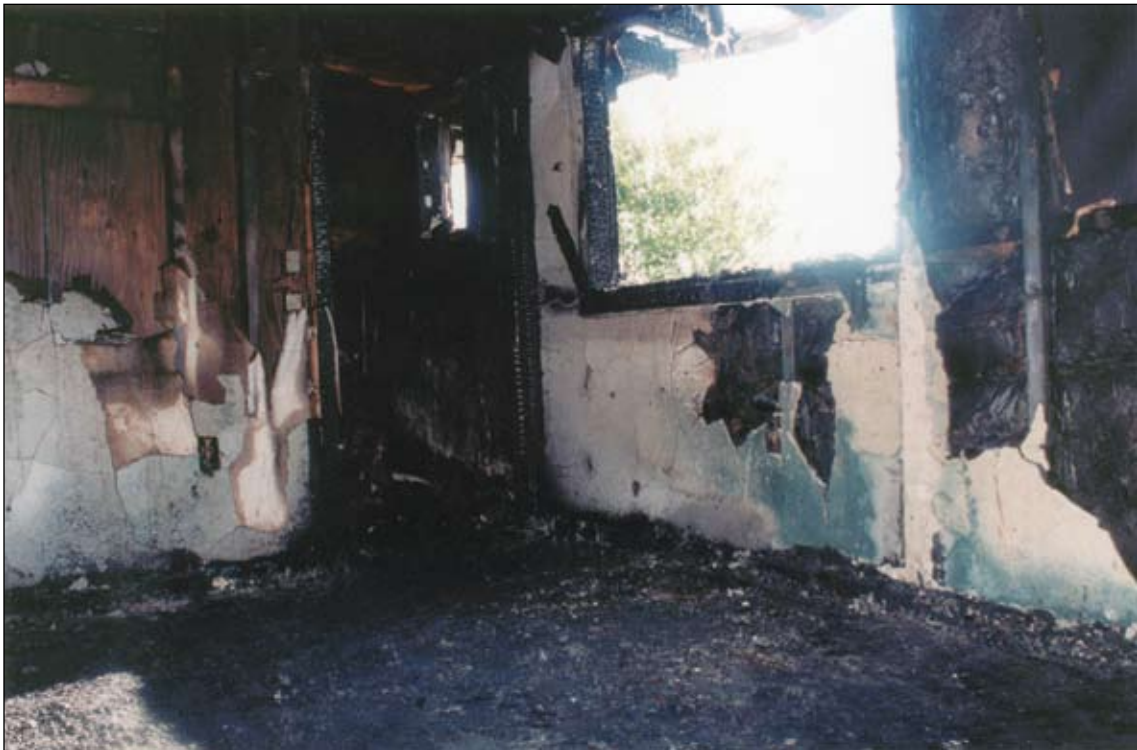
**#24** View of rear window on east side alleged to be broken by male survivor; victims three and four found just inside the window

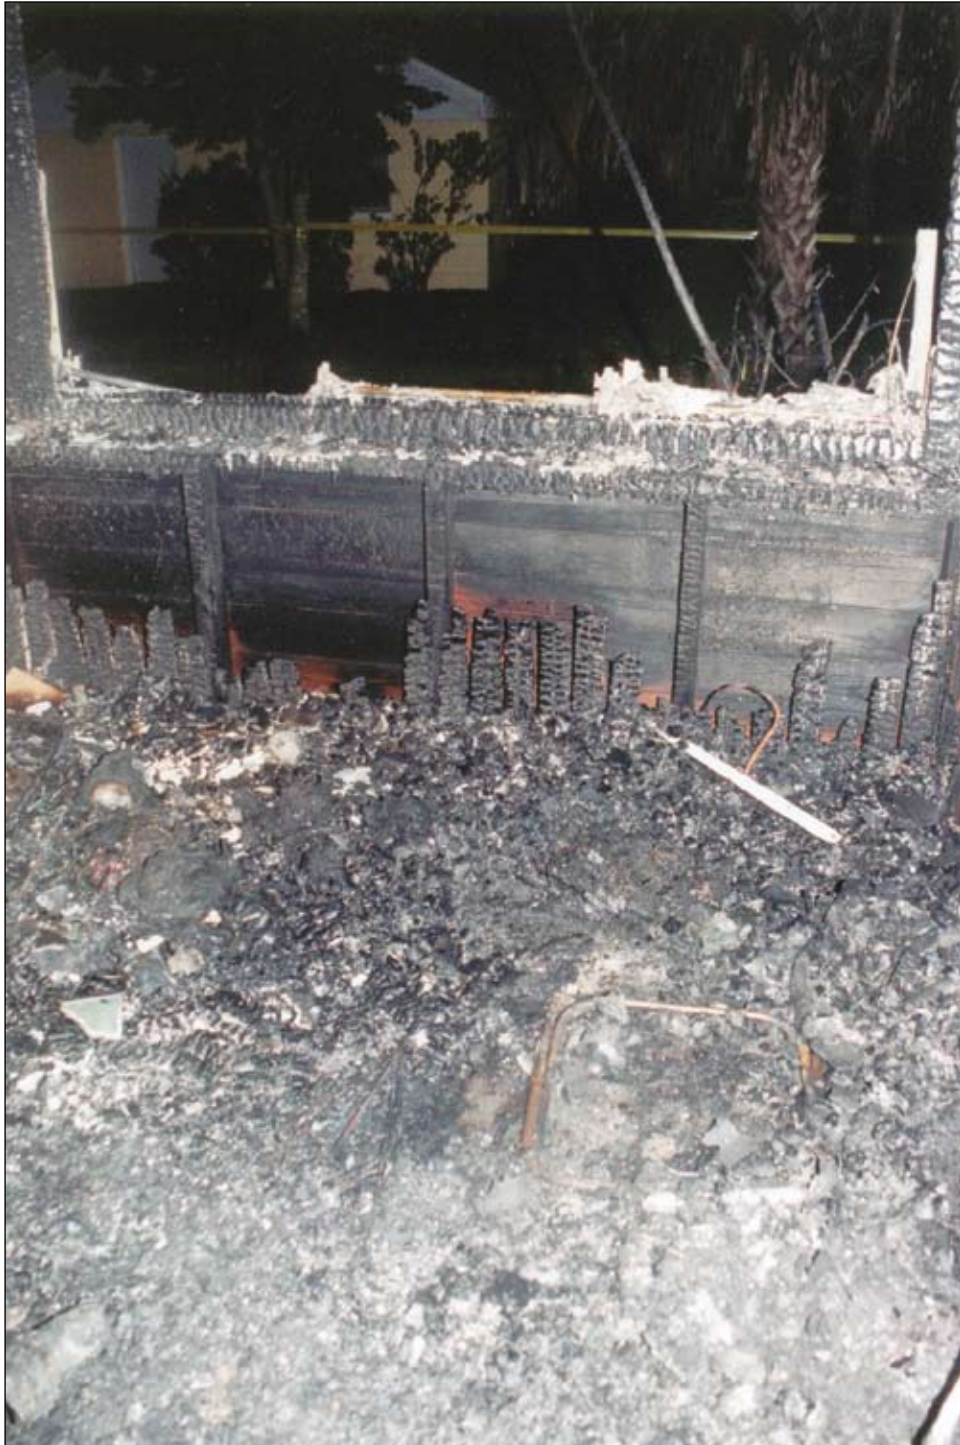
Investigators determined that a battery charger had been left plugged into an electrical outlet on the enclosed front porch of the dwelling and had caused the fire. The battery charger was not in use at the time of the fire, but had been covered by clothes and apparently overheated, igniting the blaze.

**#28 Point of origin on front porch**

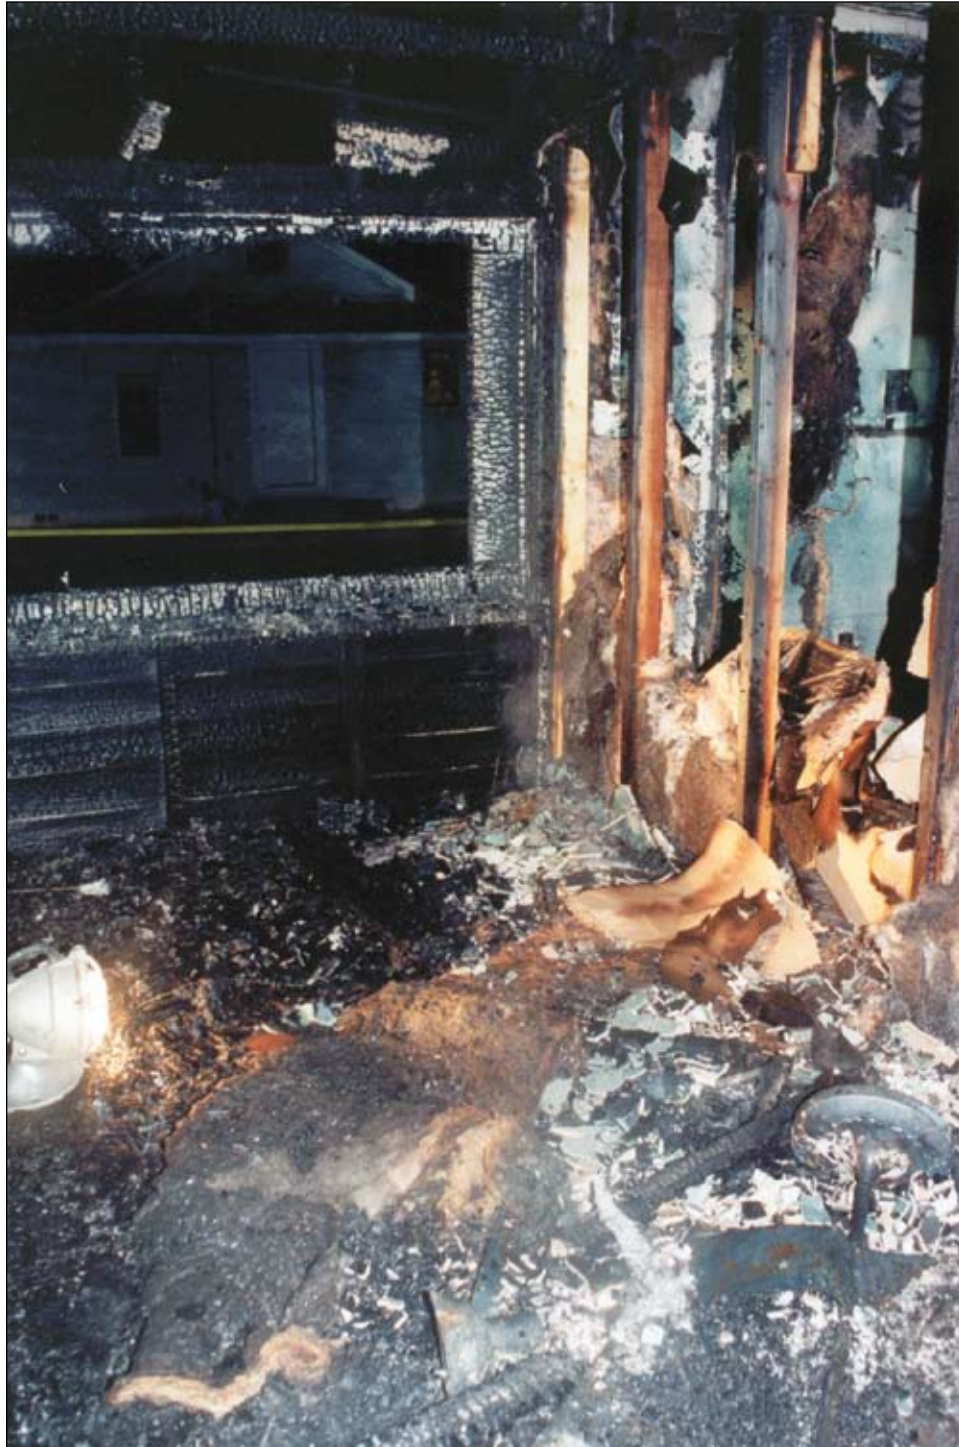
**#29** Debris at point of origin, window on left

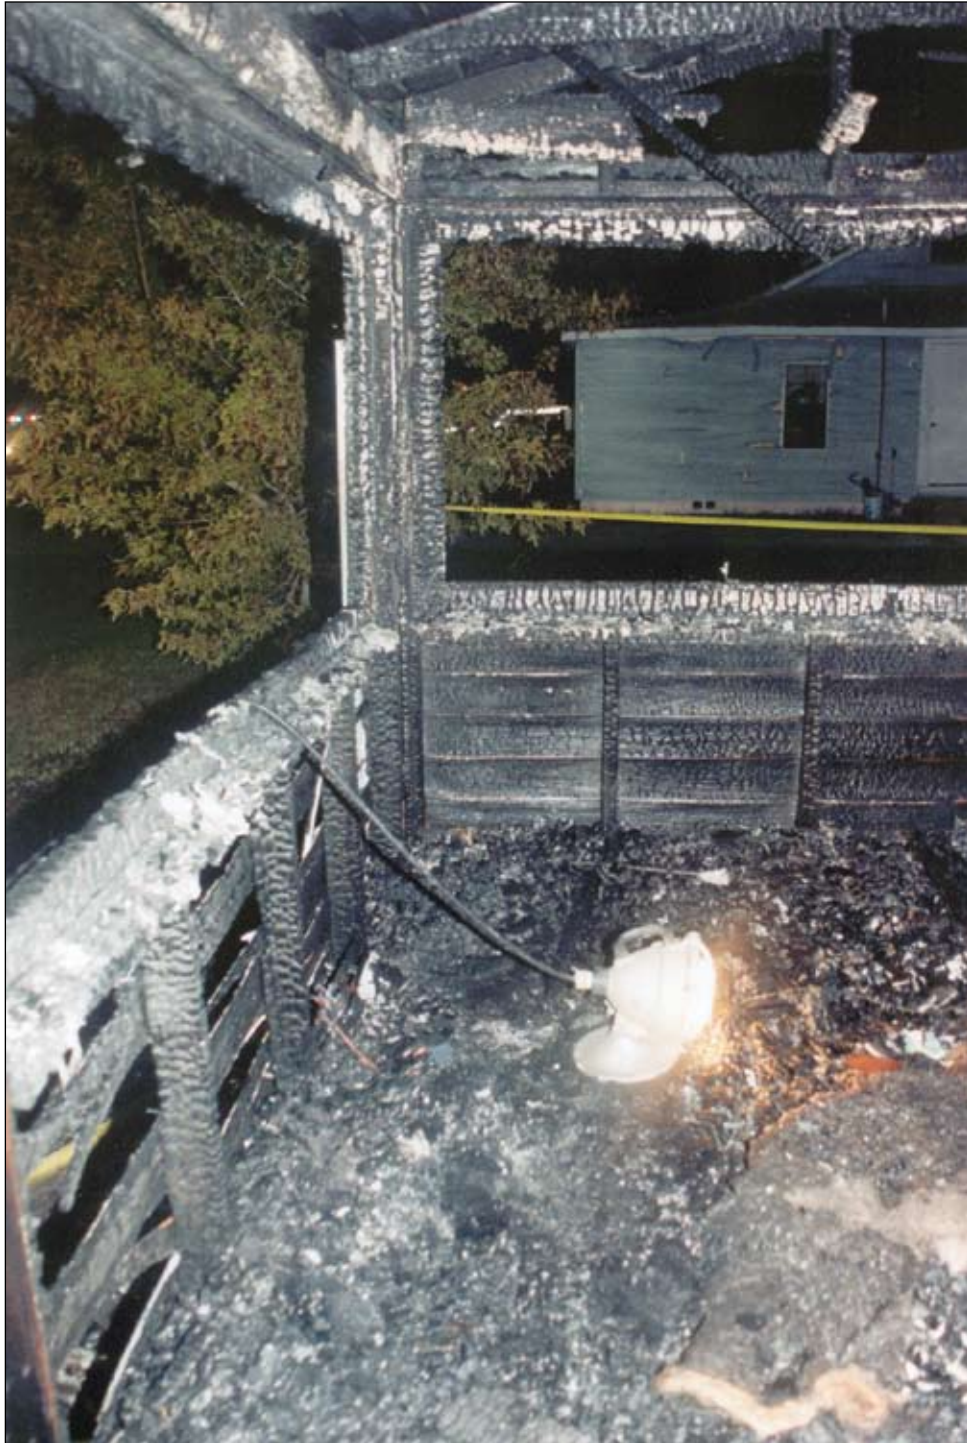
**#30 Northwest corner of front porch; note debris**

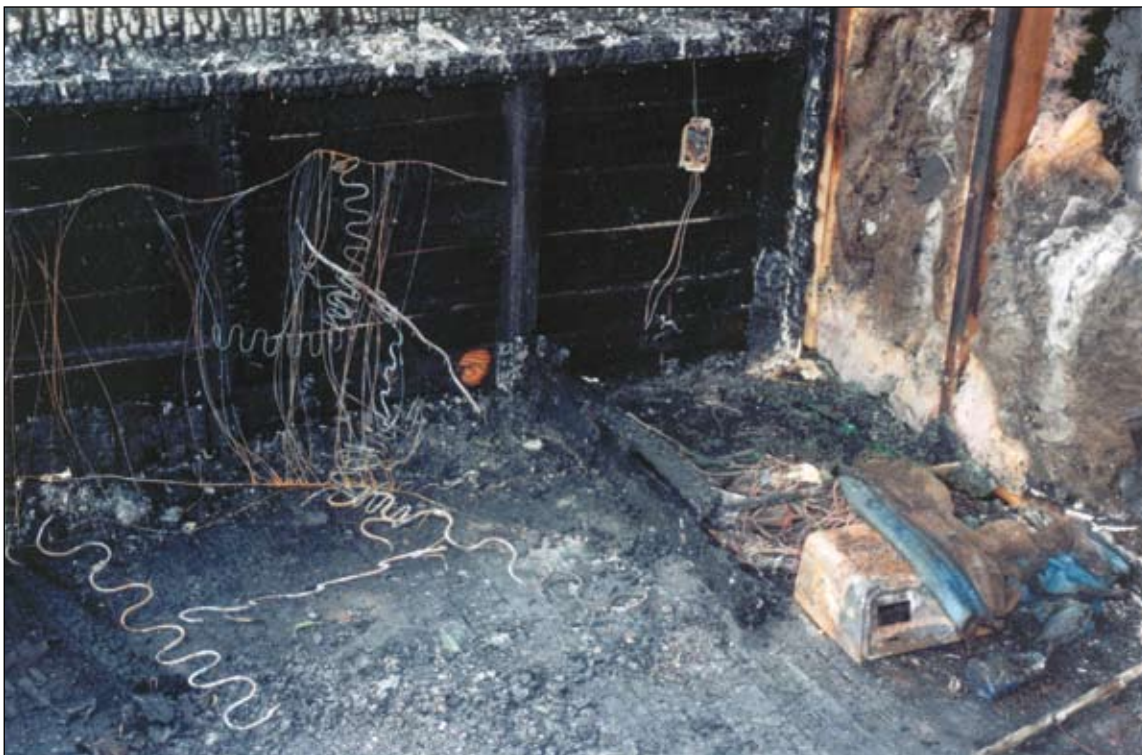
The fire was investigated by the State Fire Marshal's Office and the St. Cloud Fire and Police Departments. After ruling out all other causes, including possible criminal activity, investigators concluded that the fire was caused by a battery charger (see photos, page 40) that had been left plugged in to an electrical outlet on the front porch. The battery charger had not connected to anything at the time of ignition, but had been covered by clothes, which apparently overheated and then ignited.

**#31 Electrical outlet and battery charger at point of origin**

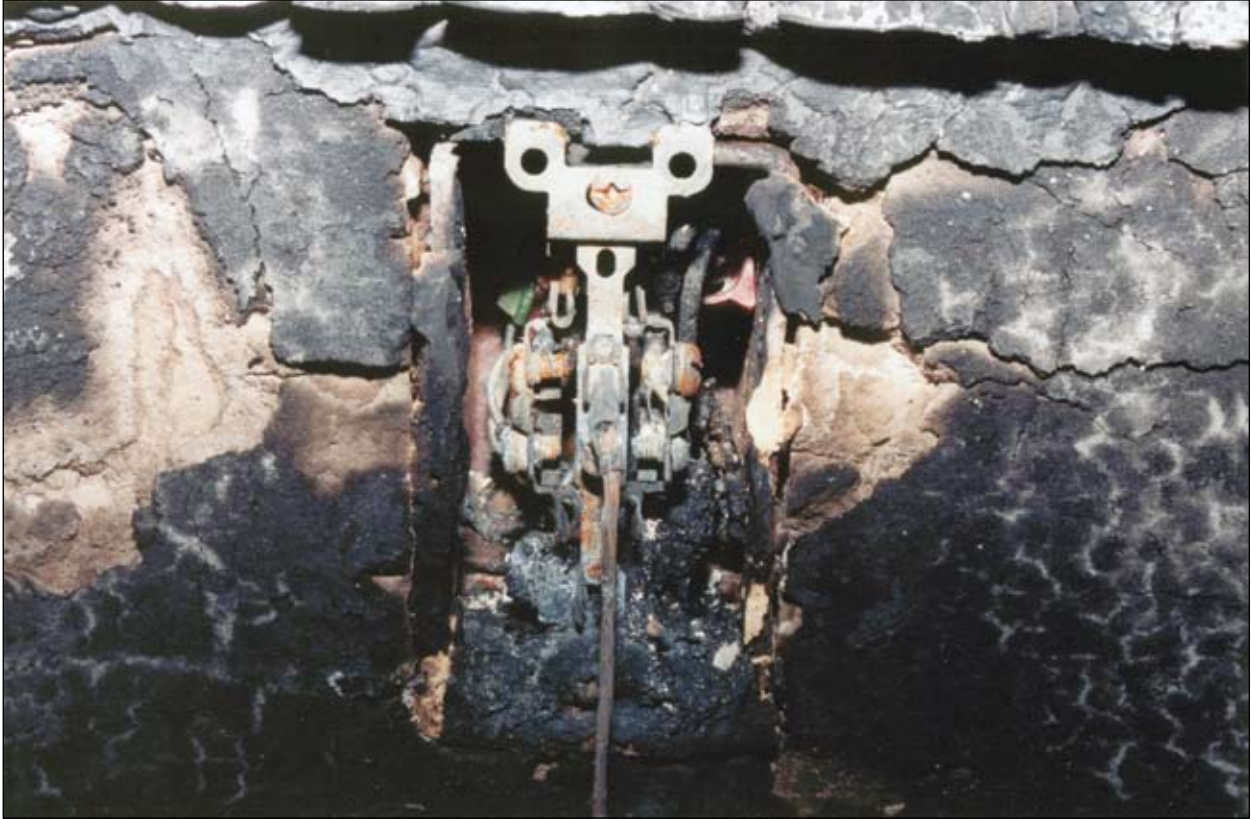
#35 Electrical outlet with battery charge still plugged into the outlet
